FYVIE CASTLE, ABERDEENSHIRE

CAMERON ARCHAEOLOGY
January 2012

REPORT ON THE EXCAVATIONS AT FYVIE CASTLE, FYC/10/1 (CA014-2010) FYC/11/1 (CA040-2011)

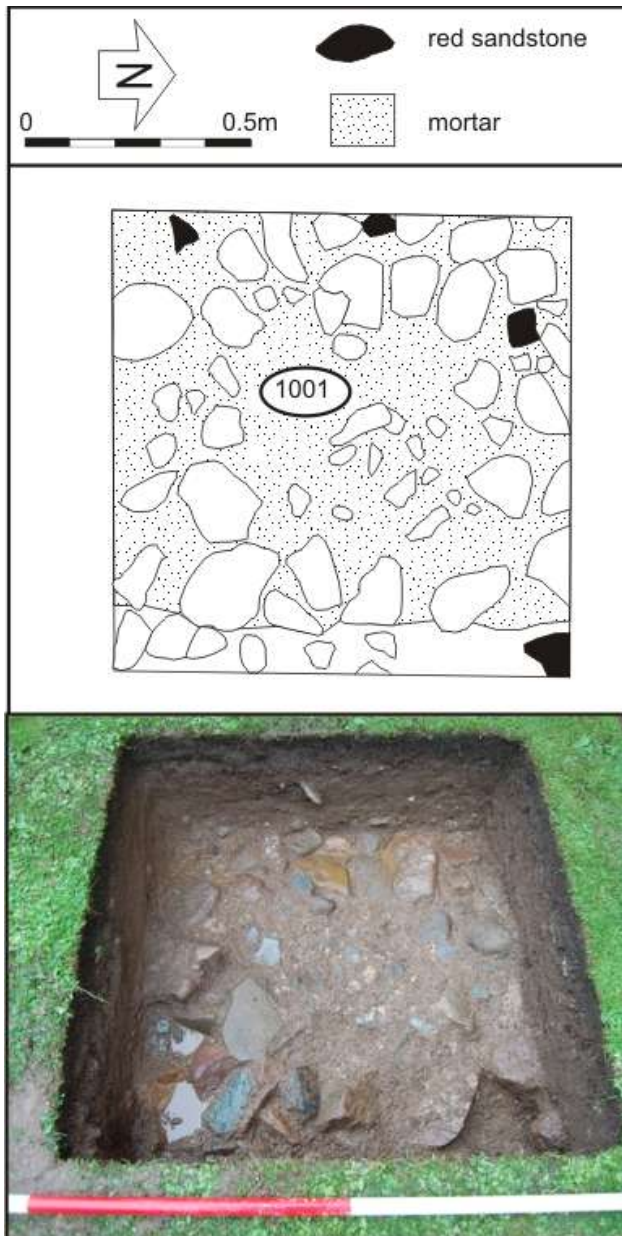
Figure 42 Trench 10 wall foundation 1002; facing west

A mortared stone feature (1002; Fig 40) included fragments of red sandstone and was covered with demolition material (1001) consisting of slate fragments, glass and nails. It was located at 55.71m OD. This was assumed to be the Inner Garden wall foundation but the position of the edge of this feature does not align with the wall in Trench 7 and as a result further excavation in this trench would be required to determine whether this trench would reveal an edge to the wall foundation. Photographs of the Preston Tower when the harling was removed in the 1960s and 1980s are being sourced and may show a scar where this wall attached.

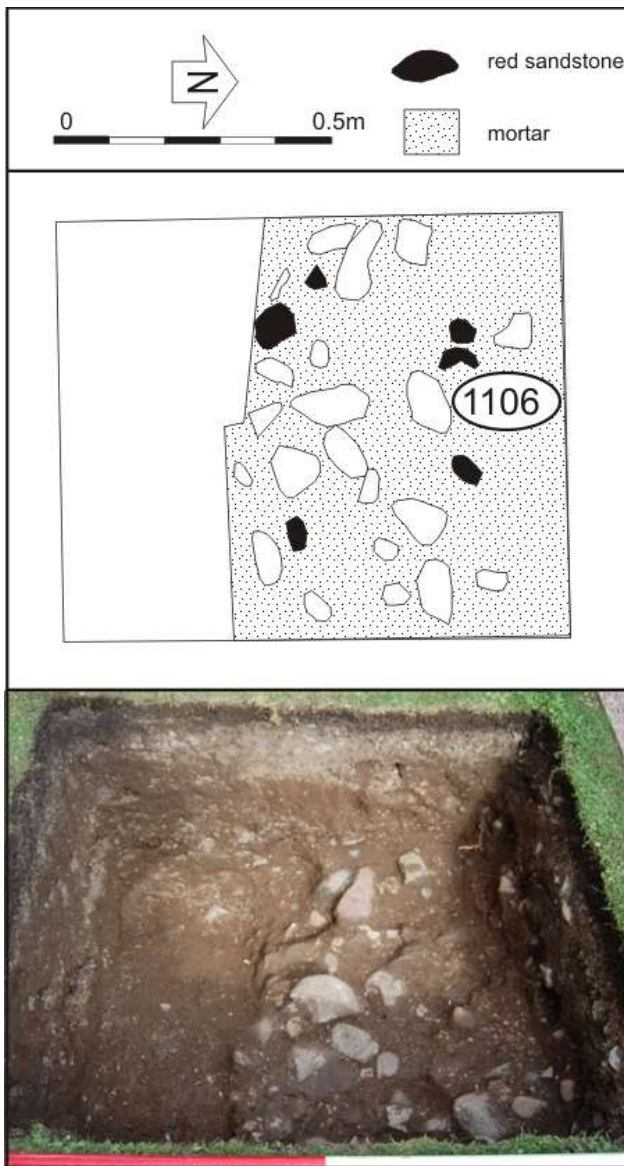
Figure 43 Trench 11 wall foundation; facing east

A stone feature (1106; Fig 43) consisted of small and medium stones including some red sandstone fragments with mortar suggesting a wall foundation. It was located in the trench at 55.72m OD. A distinct edge to this feature indicated that this was the north end wall of Building 402 (mainly excavated in 2010) making the building c 11m long internally. Following this discovery the building was measured in yards and feet and it was discovered to be 36 feet (10.98m) long and was probably 12 feet (3.66m) wide).

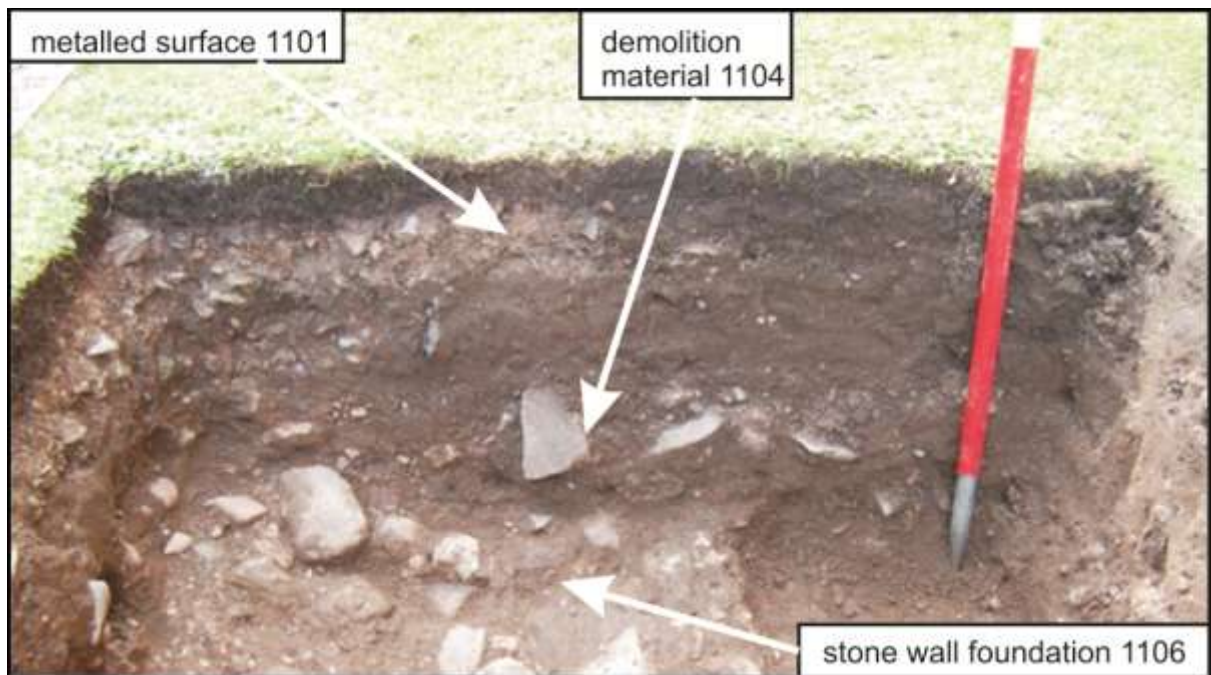
Figure 44 Trench 11 west section showing metal surface 1101 (top left) and stone wall foundation 1106 (bottom left); facing west

Above wall foundation 1108 was small stone metalled surface 1101 (Fig 44) at 56.04m OD and the remains of a wooden post (1105) edging for the surface. This probably represents an earlier alignment of the path along the south facade of the castle and can be seen in early 20th-century photographs of the castle.

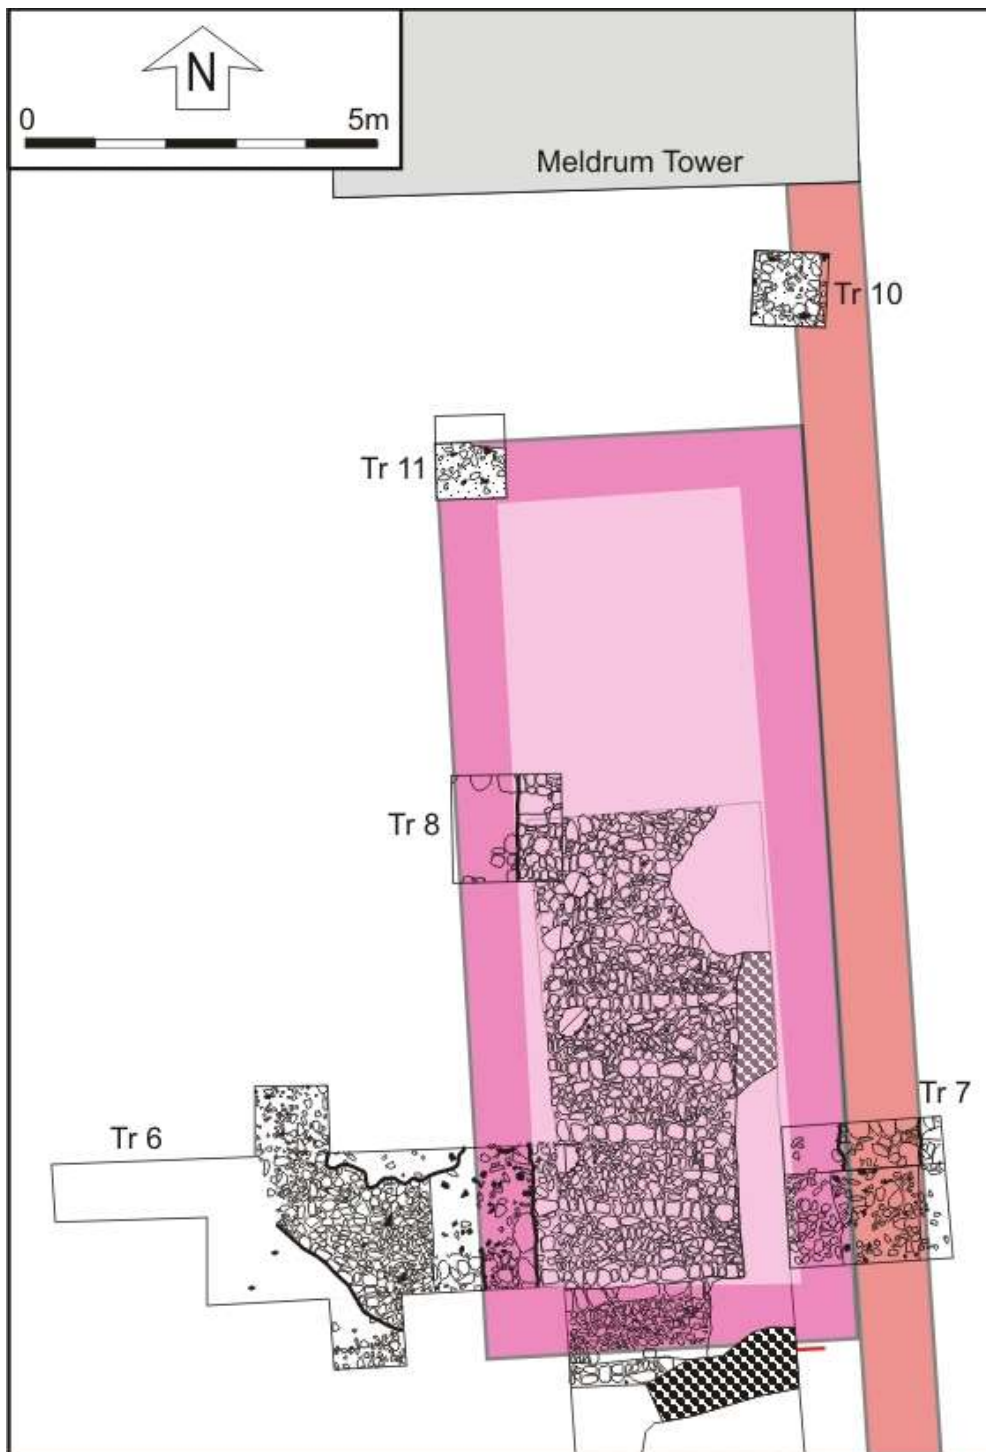
Figure 45 Possible layout for Building 402 showing garden wall (right) and chapel walls and floor (pink)

The post-holes within the building (409, 410, 411 and 412) and the raised stone (425) on the cobbled floor are the remains of internal fittings. The post-holes are close to the west wall and are likely to be the remains of a bench or other fitting built along the interior of the west wall of the building. If this building was constructed as a chapel these post-holes could have been to set a wooden bench or other piece of furniture. One post-hole which did not respect the banding of larger cobbles may represent a secondary fitting.

During the removal of the building foundations for reuse of the building materials, it is thought that up to 0.8m of the east side of the cobbled floor was removed. Other demolition of the building did not damage the cobbled floor or require removal of the cobbles. It is possible that an internal fitting was removed on this side of the building which either required the removal of cobbles or that cobbles had never been laid in this area. Further research will be required to determine what this fitting might have been.

The excavated structure had a water-washed granite cobbled floor and a slate roof; the structure included decorative sandstone elements, probably door and window surrounds, indicated by the recovery of several fragments of Old Red Sandstone. Narrow belts of Old Red Sandstone have been traced from the north coast at Peterhead by Turriff to Fyvie, and also from Huntly by Gartly to Kildrummy Castle giving several locations for quarrying the Old Red Sandstone used widely in the Oldmeldrum/Fyvie/Turriff area.

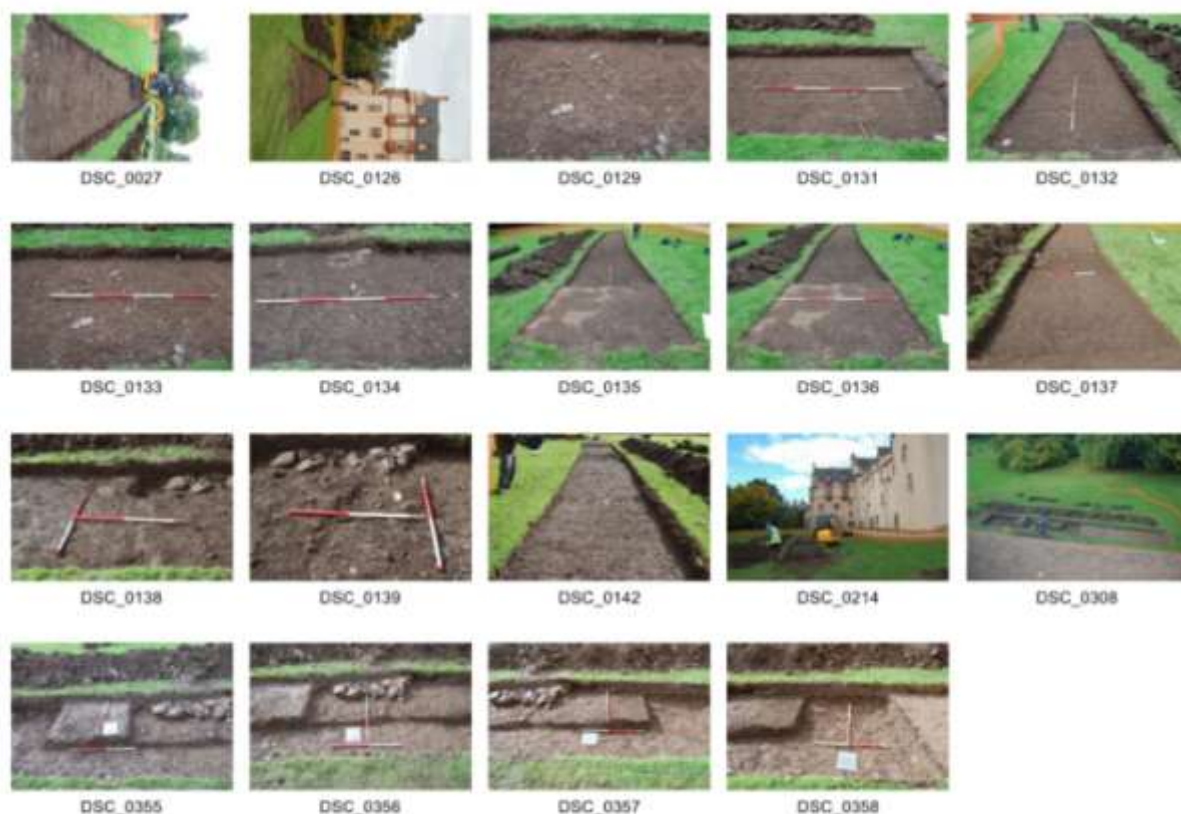
TRENCH 3

Photo no	Trench	Description	Facing
DSC_0027	3	Whole trench being machined	S
DSC_0126	3	Whole trench with castle	N
DSC_0129	3	Stones 302 before excavation	W
DSC_0131	3	North end of trench	W
DSC_0132	3	Whole trench	S
DSC_0133	3	Stones 302 before excavation	W
DSC_0134	3	Stones 307 before excavation	W
DSC_0135	3	Whole trench	N
DSC_0136	3	Whole trench	N
DSC_0137	3	Stones 307 before excavation	N
DSC_0138	3	Stones 307 during excavation	W
DSC_0139	3	Stones 307 during excavation	W
DSC_0142	3	Whole trench	S
DSC_0214	3	Whole trench being machined	N
DSC_0308	3	Whole trench from castle	W
DSC_0355	3	Stones 307 post-ex	W
DSC_0356	3	Stones 307 post-ex	W
DSC_0357	3	Stones 307 post-ex	W
DSC_0358	3	306 north of 307	W

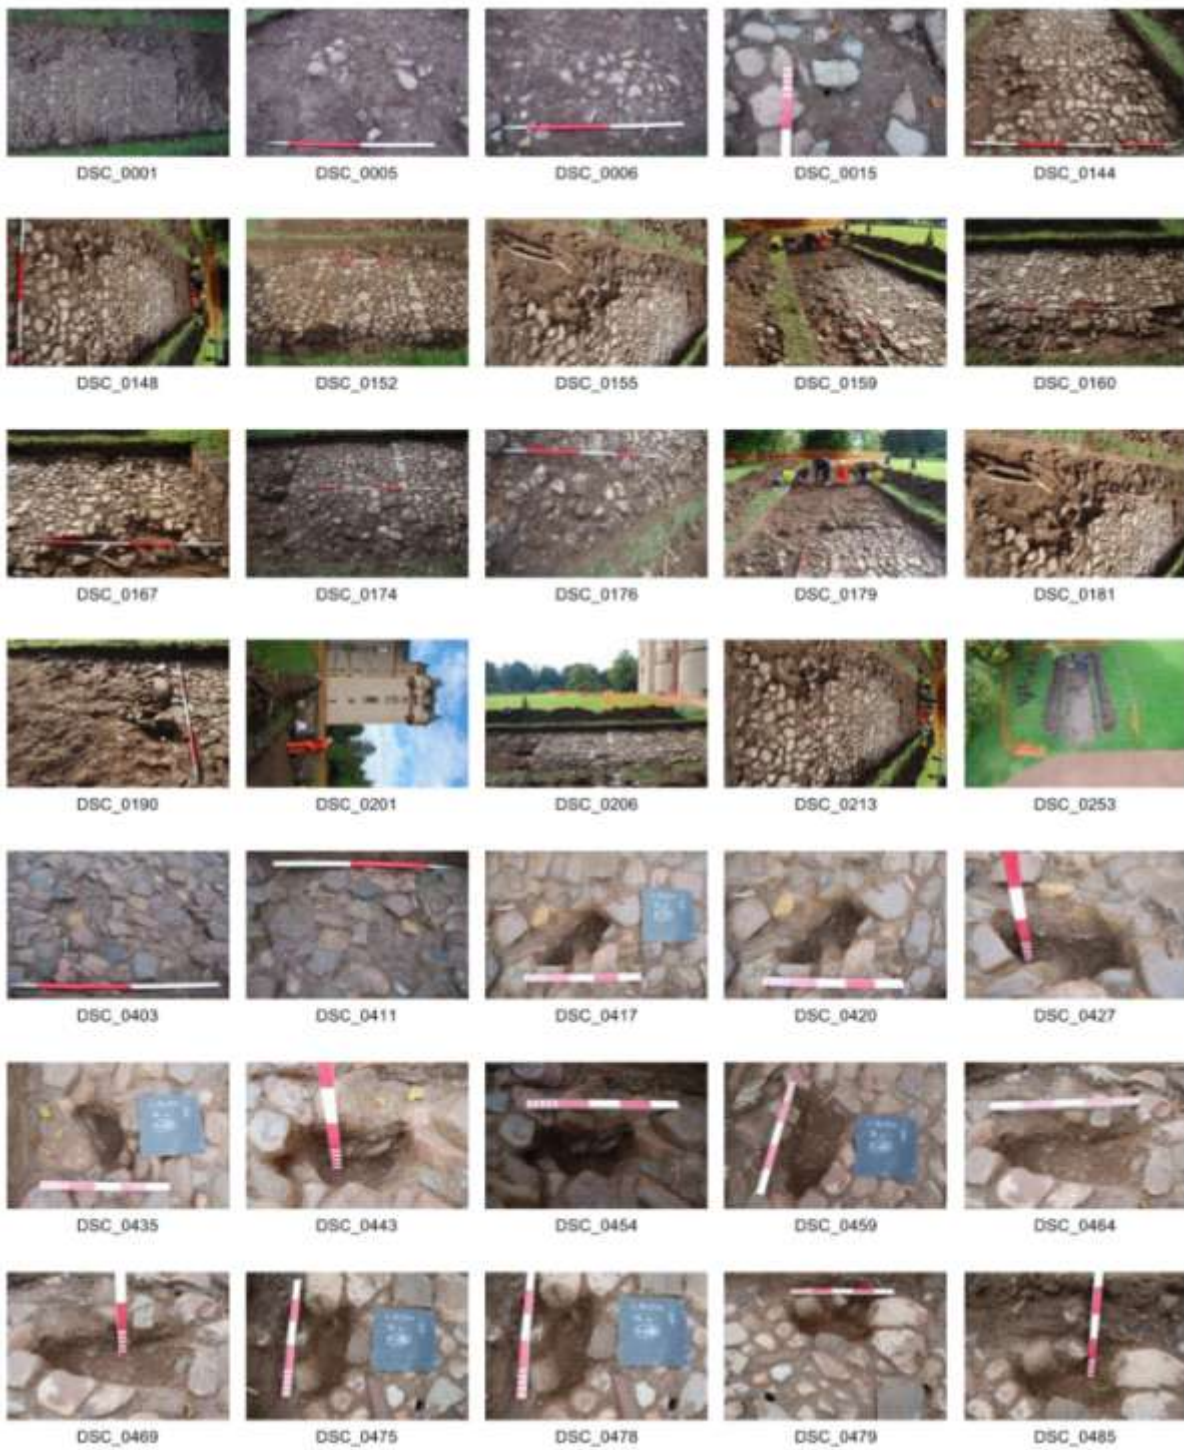
TRENCH 4

Photo no	Trench	Description	Facing
DSC_0001	4	Cobbles 402 from castle window	S
DSC_0005	4	Stones at S end metalled surface 415 (no exc)	SE
DSC_006	4	Part of metalled surface 415	E
DSC_0015	4	Hole 413	N
DSC_0144	4	Cobbles with planting pit 423 (left)	S
DSC_0148	4	Cobbles with planting pit 423 (left)	S
DSC_152	4	Central section of cobbles 402	W
DSC_0155	4	Cobbles with planting pit 423 (left)	S
DSC_0159	4	Cobbles with planting pit 423 (left)	SSW
DSC_0160	4	Central section of cobbles 402	W
DSC_0167	4	North section of cobbles 402	W
DSC_0174	4	South section of cobbles 402	W
DSC_0176	4	Stone tumble 406	N
DSC_0179	4	Cleaning metalled surface 415	S
DSC_0181	4	Cobbles with planting pit 423 (left)	S
DSC_0190	4	External cobbles 404	W
DSC_0201	4	Cleaning metalled surface 415 with castle	N

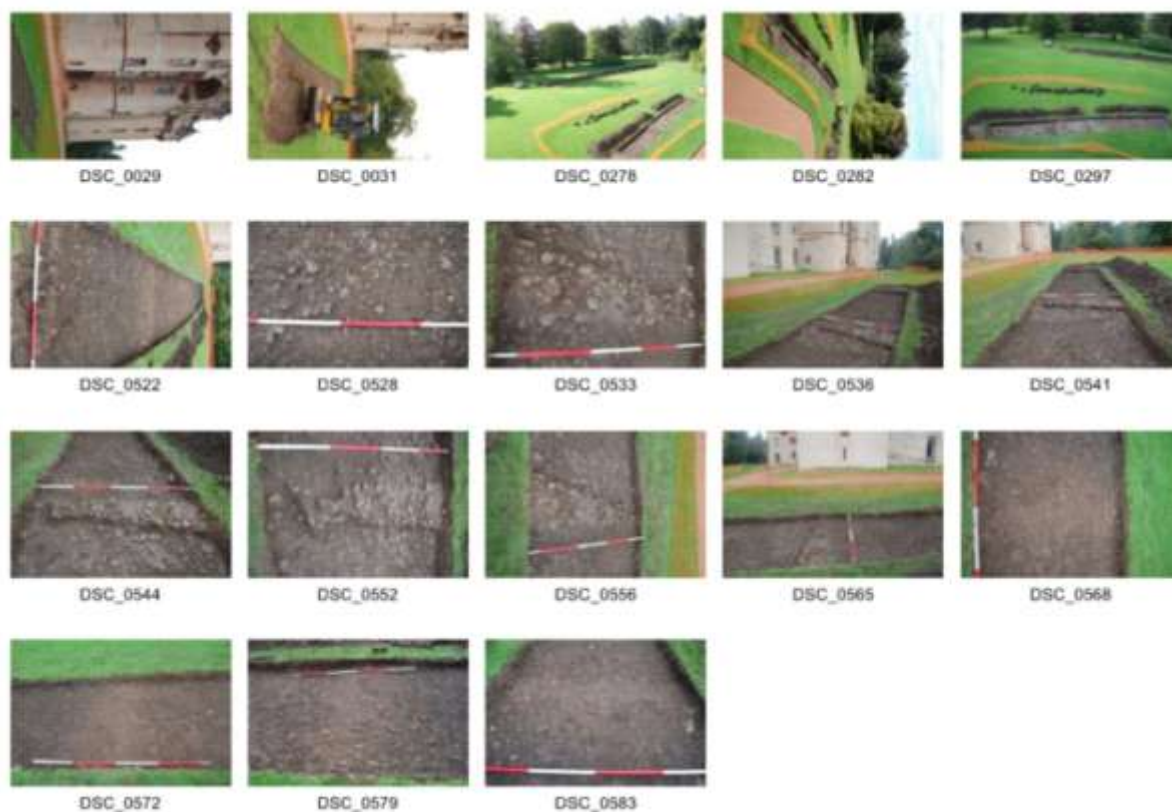
TRENCH 5

Photo no	Trench	Description	Facing
DSC_0029	5	East end of trench with castle	NE
DSC_0031	5	Trench being machined	E
DSC_0278	5	Trench from castle	SW
DSC_0282	5	Trench from castle	WSW
DSC_0297	5	Trench from castle	S
DSC_0522	5	First cleaning	E
DSC_0528	5	Holes 507 (left) 506 (right)	N
DSC_0533	5	Wall foundation 501	N
DSC_0536	5	Wall foundation 501	ENE
DSC_0541	5	Wall foundation 501	E
DSC_0544	5	Wall foundation 501	E
DSC_0552	5	Wall foundation 501	S
DSC_0556	5	Wall foundation 501	N
DSC_0565	5	Wall foundation 501 with castle	N
DSC_0568	5	Wall foundation 502	N
DSC_0572	5	Wall foundation 502	N
DSC_0579	5	Wall foundation 502	S
DSC_0583	5	Wall foundation 502	E

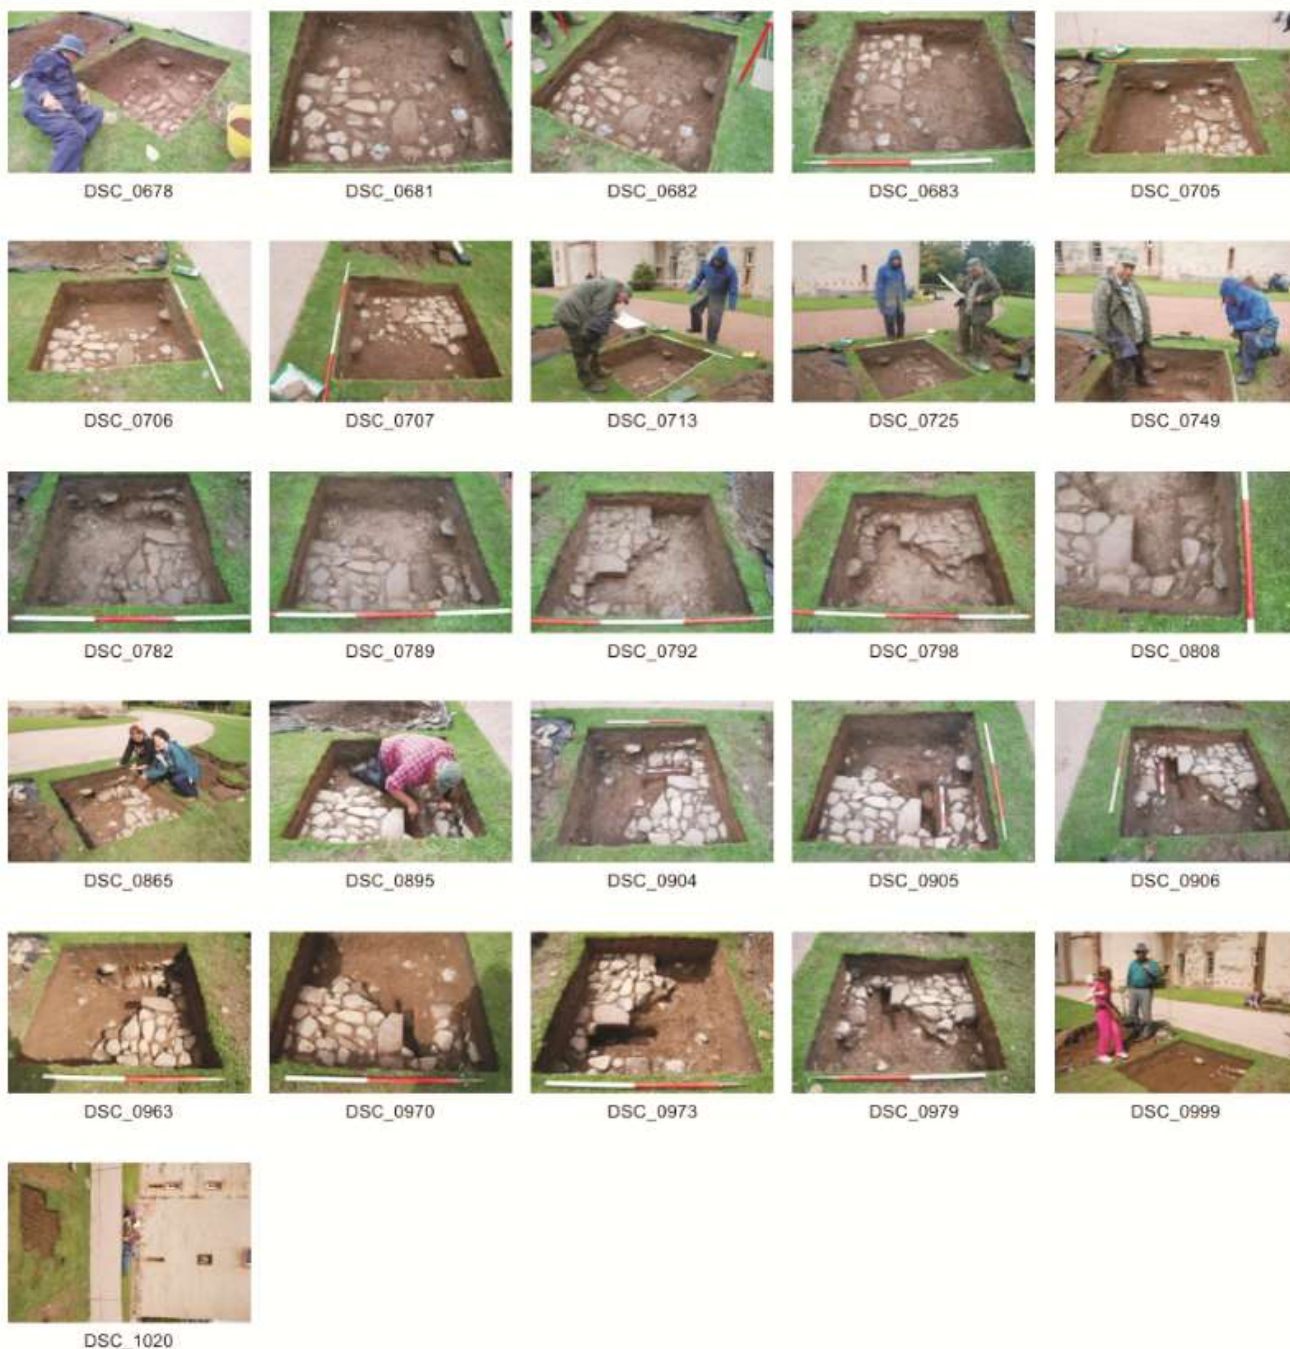
TRENCH 8

Photo number	Trench	Description	Facing
DSC_0166-7	8	Colin and David M setting out	N
DSC_0676-678	8	David M, Colin uncovering cobbles	NW
DSC_0681	8	Cobbled surface 802	W
DSC_0682	8	Cobbled surface 802	SW
DSC_0683-86	8	Cobbled surface 802	S
DSC_0687-90	8	Cobbled surface 802	W
DSC_0705	8	Cobbled surface 802	N

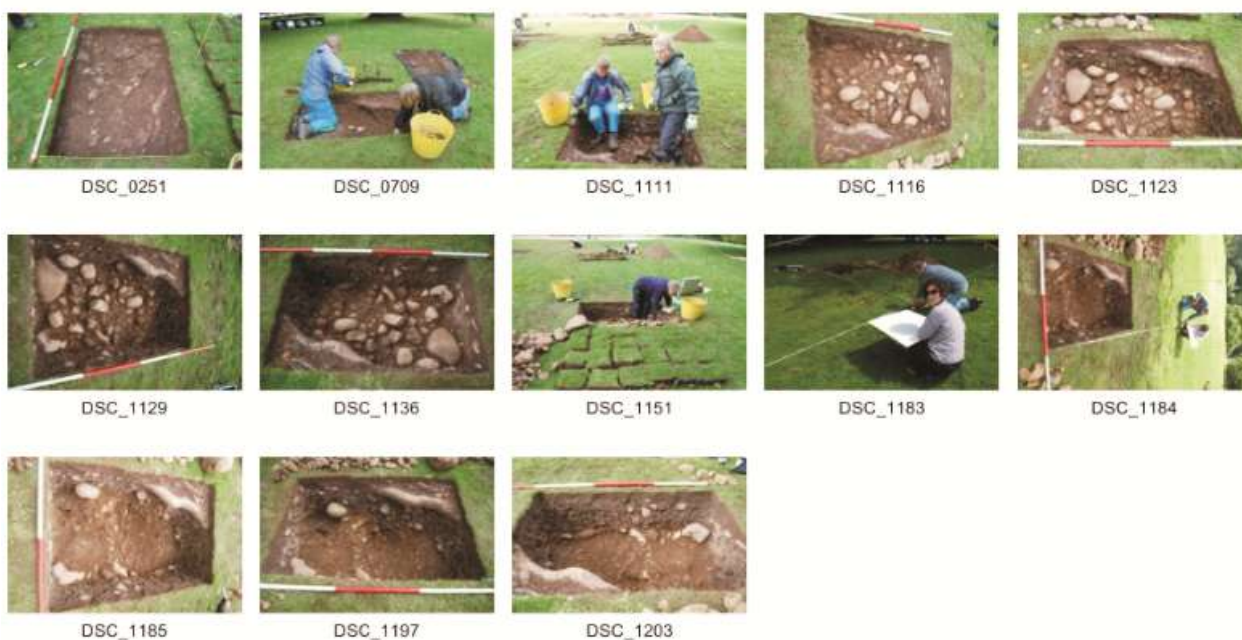
TRENCH 9

Photo number	Trench	Description	Facing
DSC_0248-9	9	Sheena	W
DSC_0250-2	9	After removal of 900	W
DSC_0699-700	9	Jan and Sheena removing 901	NW
DSC_0709-10	9	Sheena and Jan	S
DSC_1111-1113	9	Sheena and Sandra	N
DSC_1115-1119	9	Natural subsoil	E
DSC_1120-1124	9	Natural subsoil	S
DSC_1125-1129	9	Natural subsoil	E
DSC_1130-31	9	Sheena, Pete, Sandra discussing geology	N
DSC_1132-1136	9	Natural subsoil	N
DSC_1137-8	9	Sheena, Pete, Sandra discussing geology	NE/E
DSC_1139-1149	9	Natural subsoil	N
DSC_1150-1151	9	Returfing	N
DSC_1185-1194	9	Natural subsoil	W
DSC_1195-1199	9	Natural subsoil	S
DSC_1200-1209	9	Natural subsoil	N

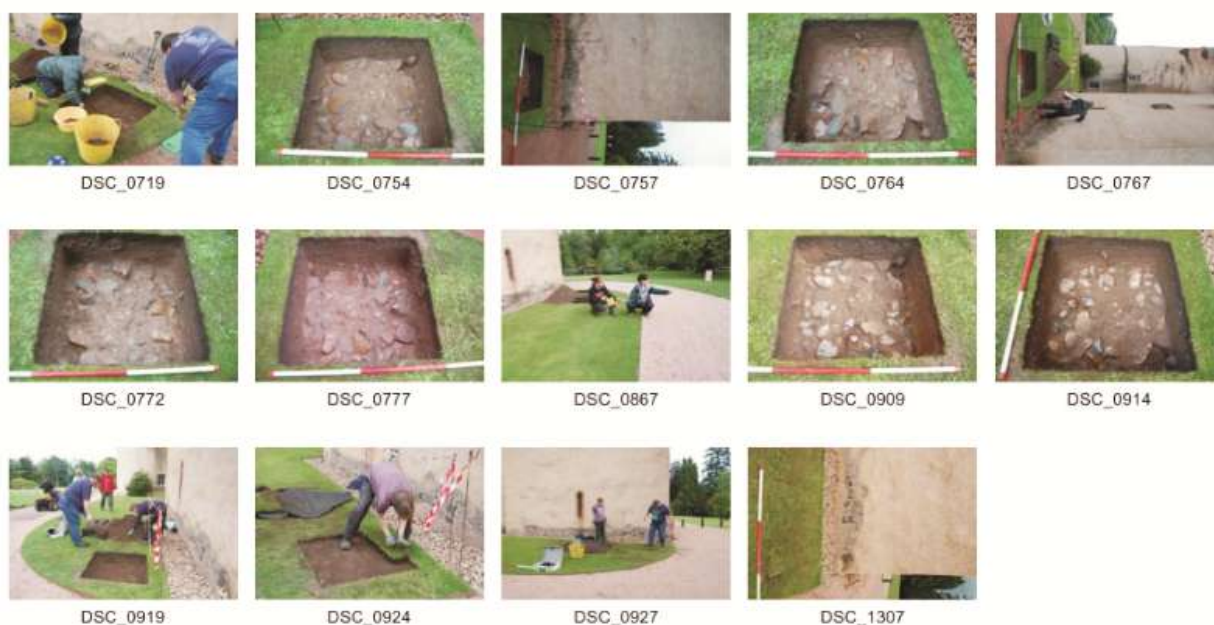
TRENCH 10

Photo number	Trench	Description	Facing
DSC_0718-719	10	Sandra, Moyra, Dougie	NW
DSC_0751-755	10	Wall foundation 1001	N
DSC_0756-760	10	Trench location	N
DSC_0761-765	10	Wall foundation 1001	W
DSC_0766-767	10	Trench location	W
DSC_0769-773	10	Wall foundation 1001	E
DSC_0776-780	10	Wall foundation 1001	E
DSC_0907	10	Dougie and Catriona	NE
DSC_0908-912	10	Wall foundation 1001	N
DSC_0913-917	10	Wall foundation 1001	W
DSC_0918-920	10	Backfilling	W
DSC_0921-923	10	Backfilling	N
DSC_0924	10	Moyra putting turves back	NW
DSC_0927-928	10	Backfilling	N
DSC_0999-1006	10	David M and Stephanie Mills backfilling Tr 10	
DSC_1305-1307	10	returfed	N

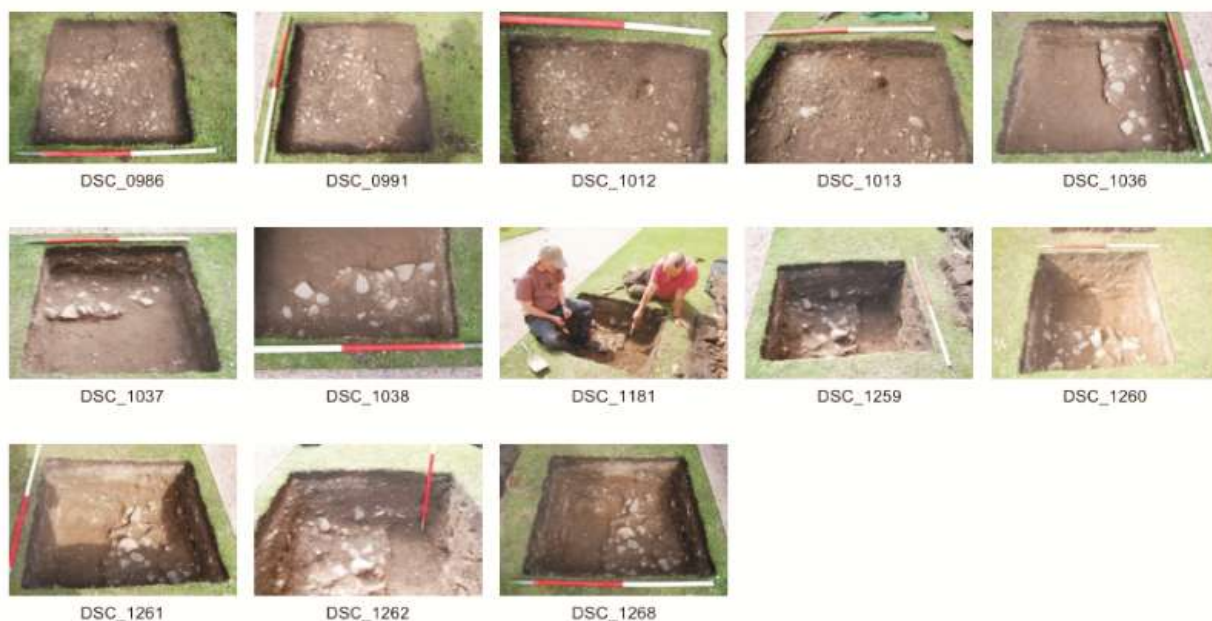
TRENCH 11

Photo number	Trench	Description	Facing
DSC_0983-987	11	Surface 1101	N
DSC_0988-992	11	Surface 1101	W
DSC_1007-8	11	Moyra (left) Dougie uncovering post 1105	N
DSC_1009-1012	11	1101 (foreground) post 1105	N
DSC_1013-1016	11	1101 (foreground) post 1105	W
DSC_1028-1029	11		N
DSC_1035	11	Moyra and Dougie discussing	N
DSC_1036	11	1104 surface	E
DSC_1037	11	1104 surface	S
DSC_1038	11	1104 surface	N
DSC_1178-1181	11	David M, Colin	SW
DSC_1259	11	Wall foundation 1106	W
DSC_1260	11	Wall foundation 1106	N
DSC_1261	11	Wall foundation 1106	E
DSC_1262-1267	11	Wall foundation 1106 & section 19	W
DSC_1268-1277	11	Wall foundation 1106 & section 19	E
DSC_1278	11	David preparing to draw section	NW
